Evaluating the Performance of a Frozen Core Dam Founded on Ice Rich Saline Marine Silts and Clays

Maritz Rykaart, Megan Millar, John Kurylo & Lowell Wade
SRK Consulting (Canada) Inc., Vancouver, British Columbia, Canada

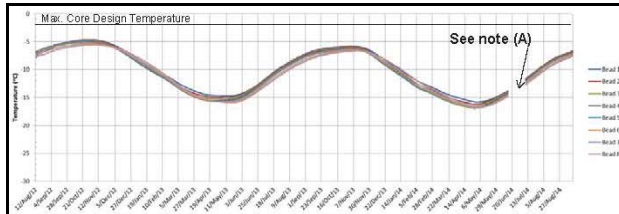
Figure 5. Time series data for ground temperature cable ND-HTS-130-33.5

In accordance with the design criteria, the North Dam core must at all times remain at a temperature below -2°C . The horizontal GTCs which are specifically focussed towards confirming this, clearly demonstrate that this design criteria is comfortably being met. This is illustrated

in Figures 5, 6 and 7 for the horizontal GTCs at chainage 0+130 m. Note (A) on these figures denotes a period when the data logger was not functioning supporting the conclusion that the data loss experienced does not detract from the ability to reach definitive conclusions about the dam performance. Not surprising, this data also shows greater annual variability in the core temperature where the core is closer to the surface.

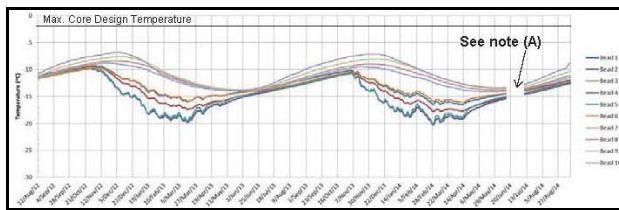
Figure 7. Time series data for ground temperature cable ND-HTS-130-28.8

Figure 7 also demonstrates how effective the thermosyphons are in cooling down the core and foundation. The lower three beads of GTC ND-HTS-130-28.8 shows markedly lower temperatures than the other beads of the same strings. These beads are in close vicinity of the thermosyphons and are therefore the lowered temperatures are recorded.

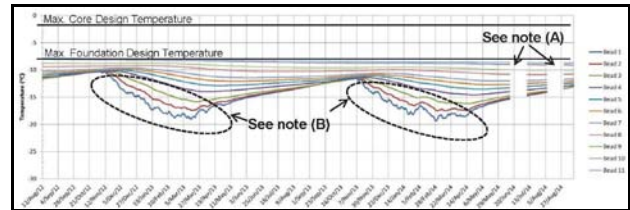
Figure 8. Time series data for ground temperature cable ND-VTS-060-KT

The vertical GTCs are intended to demonstrate that the critical section of the foundation immediately below the key trench will remain below -8°C in accordance with the design criteria. The monitoring data shows that this criteria is generally being met, although not as consistently as for the core. Figure 8, illustrates a time series plot for vertical GTC ND-VTS-060-KT which is an example where the criteria is being met, while Figure 9 and 10 show some of the exceptions.

Note (B) on Figure 8 provides another example of how the cooling effect of the thermosyphons is confirmed through monitoring.

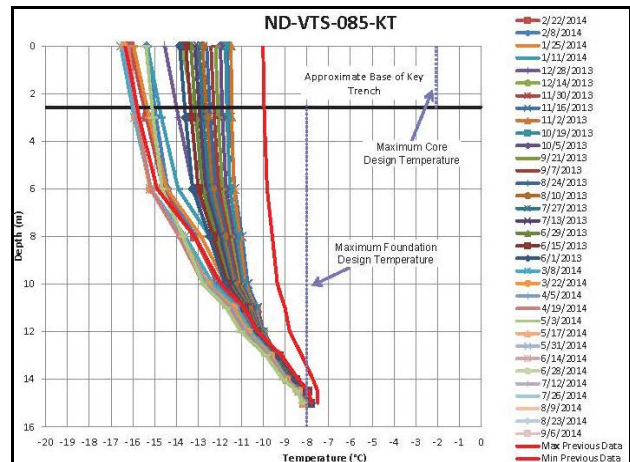
Figure 9. History of ground temperature cable data for ND-VTS-085-KT

The bottom two beads (beads 10 and 11) of ND-VTS-085-KT have a measured maximum temperature between -7.5°C and -8°C (Figure 9). This is sufficiently close to the required design temperature to suggest that the design target has been met.

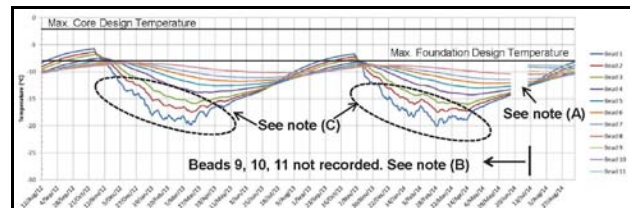
Figure 10. Time series data for ground temperature cable ND-VTS-175-KT

The measured maximum foundation temperatures directly below the frozen core for GTC ND-VTS-175-KT were approximately -6°C from May 2013 to September 2014. However, the maximum measured temperature has decreased from the maximum measured temperature May 2012 to May 2013 (Figure 10). Should this cooling trend remain consistent, it is expected that the required design temperature would be reached within the next year.

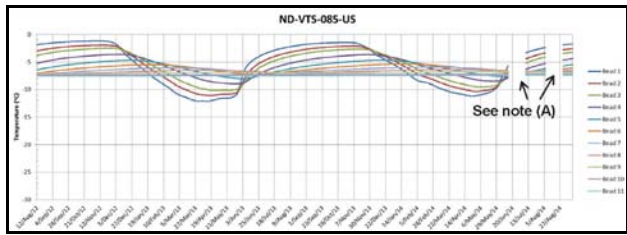
Figure 11. Time series data for ground temperature cable ND-VTS-085-US

The maximum measured temperatures of near surface beads for vertical GTCs upstream and downstream of the key trench were between 0°C and -1°C in 2014. These maximum measured temperatures were generally colder than what was recorded in 2013 suggesting a definitive cooling trend. These warmer temperatures are however

consistent with the design thermal modeling. Figure 11 provides an example of this for GTC ND-VTS-085-US.

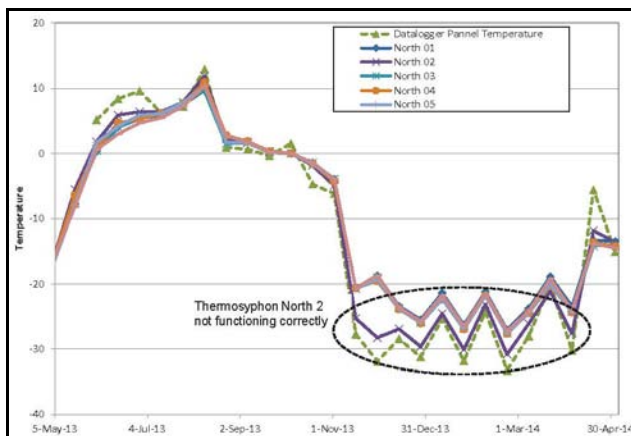
Figure 12. North Dam northern embankment thermosyphon performance time series

All six of the southern embankment thermosyphons have been confirmed to function correctly. Figure 12 illustrates that all but one (North 2) of the six northern embankment thermosyphons are functioning as intended. During the winter months of 2012/2013 and 2013/2014, the measured pipe temperature for thermosyphon North 2 was only slightly higher than the measured air temperature.
