FINDINGS OF INTERNATIONAL REVIEW OF SOIL COVER DESIGN AND CONSTRUCTION PRACTICES FOR MINE WASTE CLOSURE¹

Maritz Rykaart, Daryl Hockley, Michel Noel, Michael Paul²

¹ Paper presented at the 7th International Conference on Acid Rock Drainage (ICARD), March 26-30, 2006, St. Louis MO. R.I. Barnhisel (ed.) Published by the American Society of Mining and Reclamation (ASMR), 3134 Montavesta Road, Lexington, KY 40502

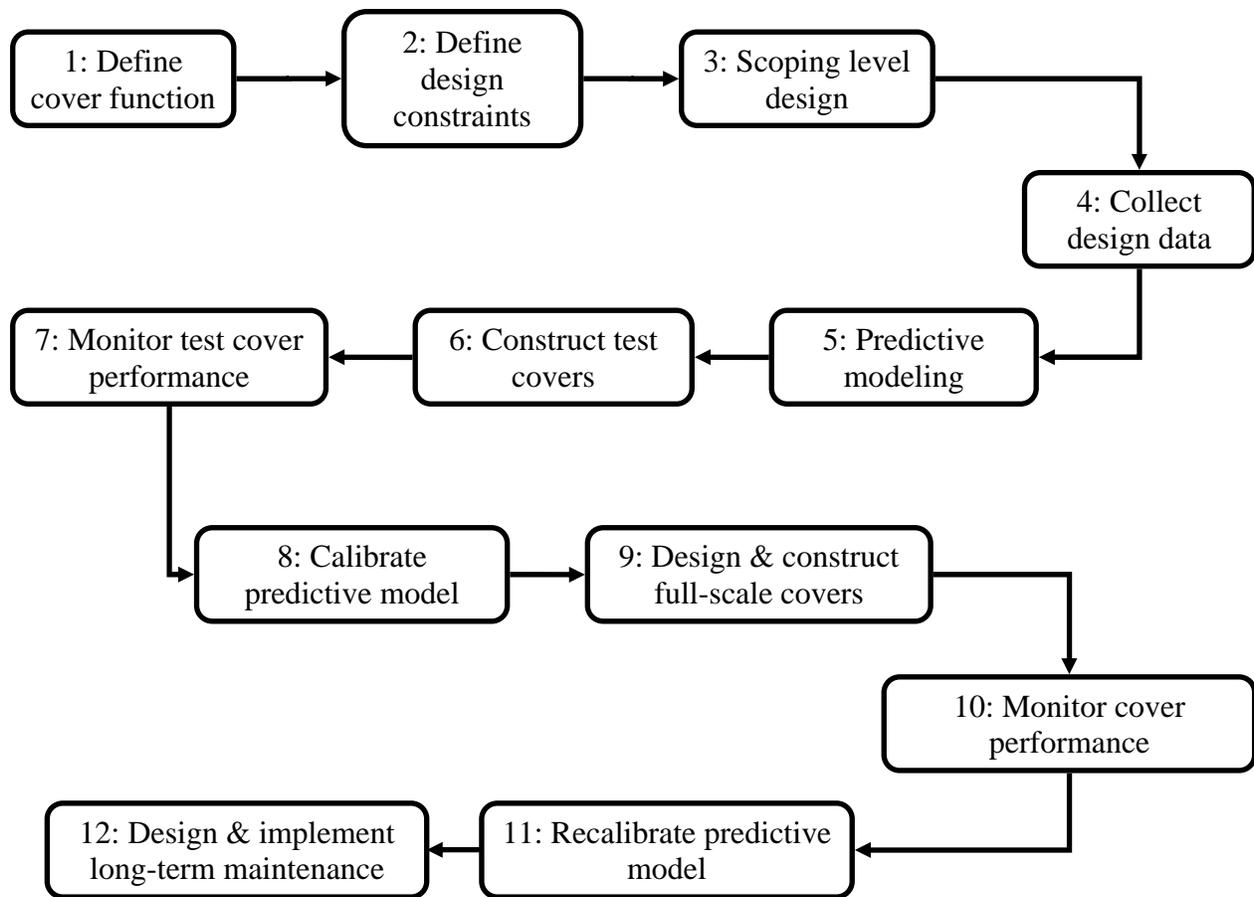
As a result of the review undertaken by SRK, a formalized approach to cover design is proposed, as illustrated in Fig. 1. This is a summary of the general steps that most practitioners follow in cover design. Since cover design is a very site specific issue, this approach should be viewed as a guide; however, all the design processes reviewed in the case studies generally followed most, if not all, of these general steps.

Figure 1. A proposed formalized cover design procedure as evaluated from the international cover design and construction review.

The complete formalized approach (Steps 1 through 12 in Fig. 1) has been followed successfully in a number of actual case studies; Kidston Gold Mine (Durham 2002), AA Heap Leach Pad (Zhan *et al* 2001), Les Terrains Auriferes (MEND2.22.4a 1999), Whistle Mine (Ayres *et al* 2002) and Wismut being good examples. Sites where this approach has been adopted, but not yet fully implemented (i.e. only up to Steps 7, 8 or 9), include Mt. Whaleback (O’Kane *et al* 2000), Grasberg, Kestrel Coal, Syncrude (Meiers *et al* 2002), Kaltim Prima Coal, Questa Mine (Wels *et al* 2002) and Greens Creek.

There are also a number of case studies where the cover construction has been completed without pilot scale work, with the cover performance based solely on uncalibrated numerical modeling (i.e. skipping Steps 6 though 8). For these case studies cover performance monitoring

However, by far the majority of full scale covers being constructed are done without any pilot scale testing or calibration monitoring at all (i.e. moving straight from Step 5 to Step 9 and ending there. Examples of this approach include the Vangorda waste rock pile (SRK 1994a, 1994b), Yankee- and Coral Gold heap leach pads, and the Glamis waste rock dumps and heap leach pads. Although the review identified many more sites where this approach is adopted, there is generally very little in the form of published documentation explaining the reasoning behind this decision. Drummond *et al* (2003) reports on the cover designed for the Tonopah heap leach pad, where no design was done at all. Their approach was simply to adopt a design similar to those in the surrounding areas and apply that – the premise being that if it works elsewhere, it is good.

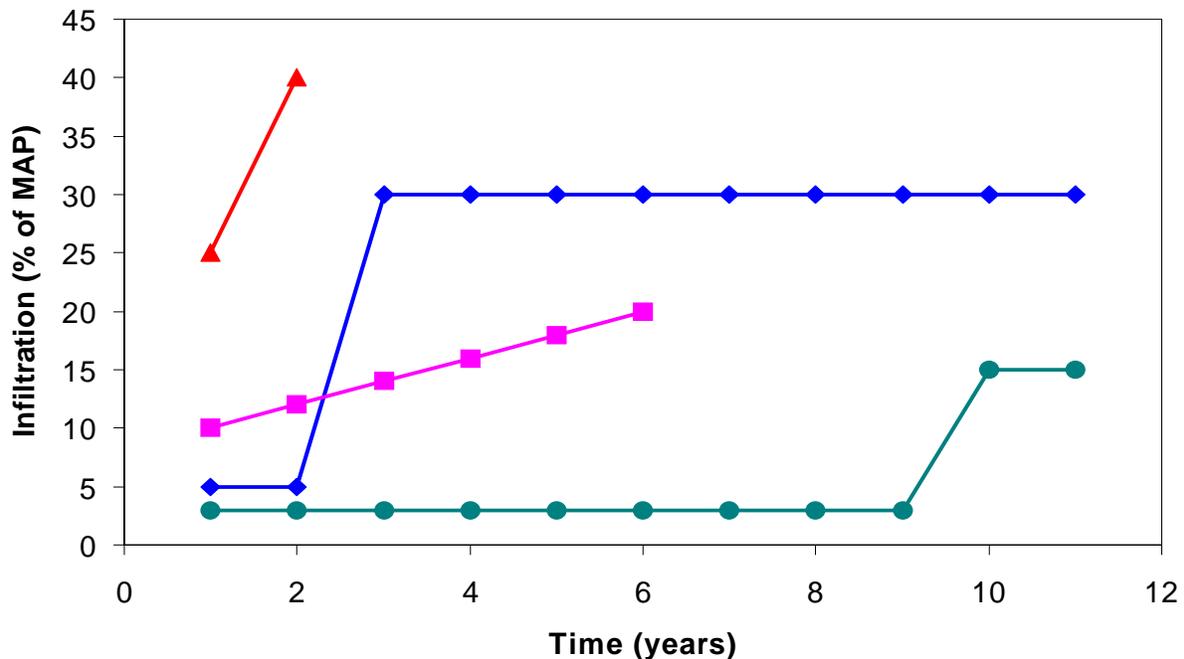
Cover performance data, such as that illustrated in Fig. 2, are now starting to become available. The figure illustrates reliable cover performance data for four case studies in the form of percolation measurements, i.e. infiltration that passes through the cover (this data is expressed as a percentage of the Mean Annual Precipitation (MAP)). In all cases there has been a significant increase in infiltration over time. The increased infiltration appears to be as a result of increased hydraulic conductivity of the cover material. The obvious question is why are these trends observed, i.e. are they as a result of inevitable natural physical changes that occur in exposed soils, or are the changes perhaps due to improper construction practices? The answer to this question is not clear; however, Figure 2 does demonstrate three interesting trends. Firstly, in all four case studies the infiltration increased, and did not decrease, suggesting an irreversible process. Secondly, in two case studies the increase was rapid, i.e. a sudden jump within a one year time frame, suggesting a trigger event of some kind. Finally, the remaining two case studies suggest a gradual increase in infiltration over time, suggesting progressive changes.

In all four the demonstrated case studies the design infiltration rate was in part reliant on a specific soil hydraulic conductivity, which was to be achieved through compaction. Therefore, the change in hydraulic conductivity which leads to increased infiltration constitutes a failure of the cover.

Figure 2. Four case studies for which long-term monitoring data shows persistent increase in infiltration over time.

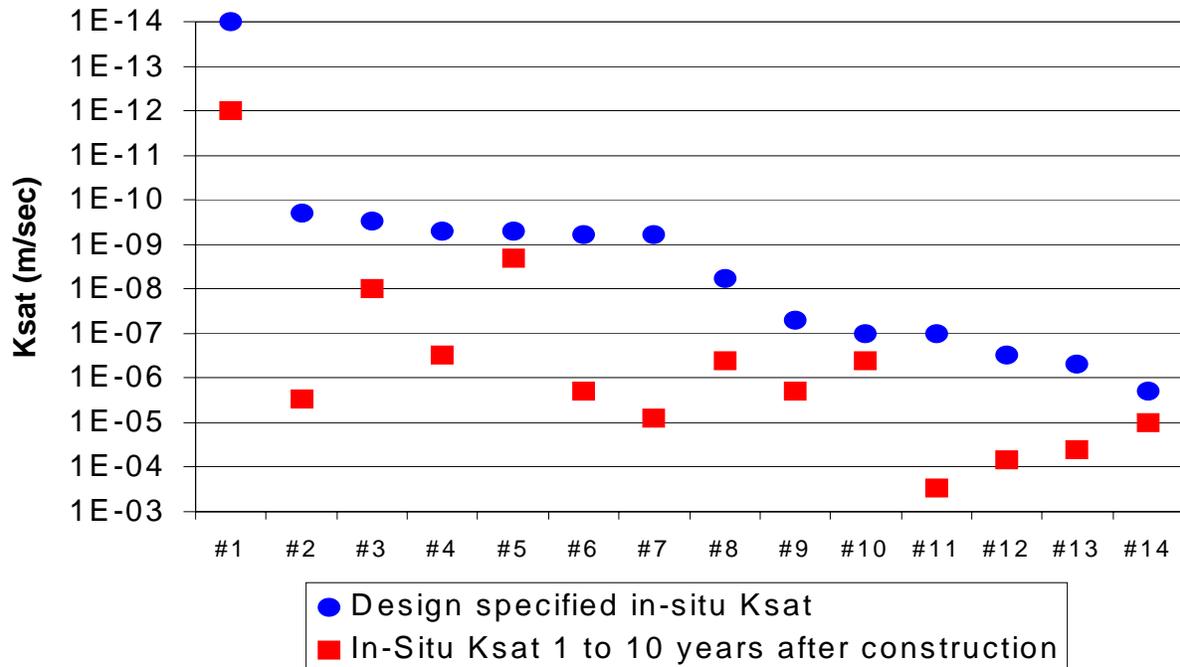
Increasing hydraulic conductivity of the cover material over time, as well as the difference between the design specification and that measured in situ is depicted in Fig. 3 for 14 case studies. Clearly, differences of one to three orders of magnitude between design and measured values are not uncommon, and as a result covers are not performing as intended (especially, since allowance for such changes are generally not considered in the designs). Perhaps these changes are to be expected, since soil covers are dynamic, and soil properties should change over time, especially when these soil covers are subjected to wet/dry and freeze/thaw cycles. However, irrespective of these facts, when a soil cover is designed to a specific hydraulic standard for a given lifetime, that standard should be met; otherwise the cover constitutes a failure.

Figure 3. Case studies demonstrating how actual field measured hydraulic conductivities vary from those specified during the design stage.

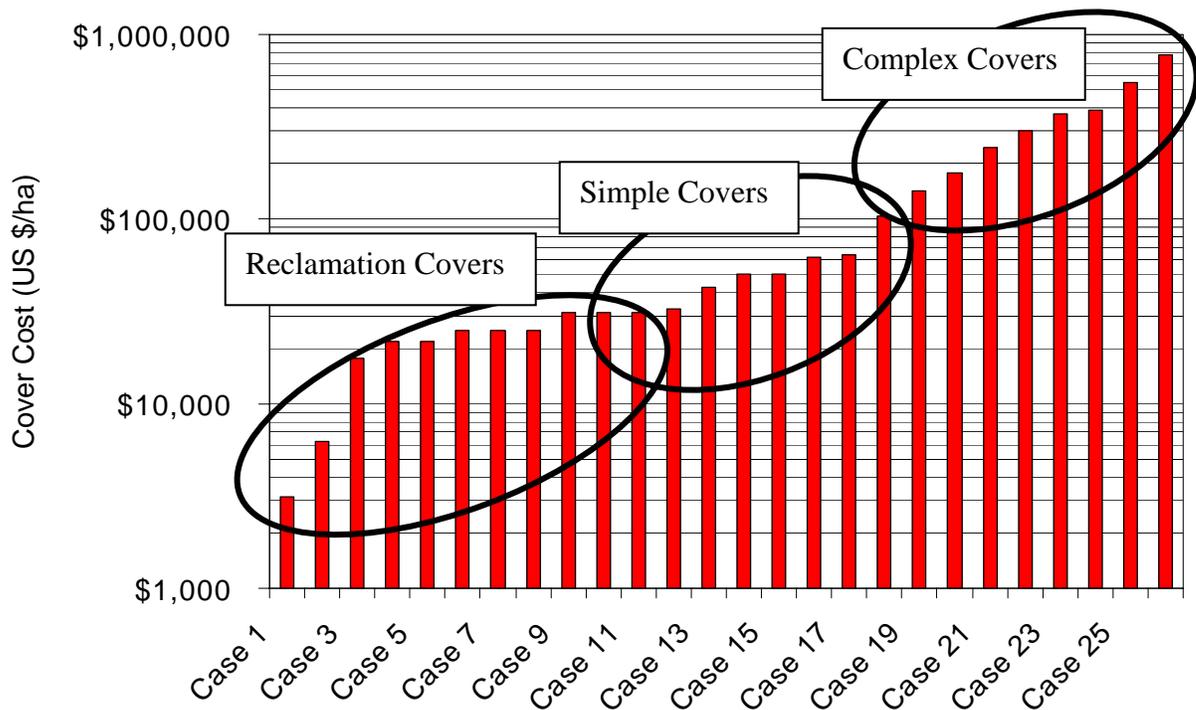
Figure 4 summarizes a small number of case studies for which cover construction costs are available. These are not directly comparable in all cases, since data on exactly how they have

been derived are scarce; however, the trends in the data appear consistent. Simple reclamation covers cost are the least expensive, generally less than US \$20,000/ha. Simple single layer infiltration reducing covers can be up to US \$100,000/ha, whilst multilayer complex infiltration reducing covers can be up to US \$500,000/ha. Based on the costs evaluated during the review the median cover cost is in the order of US \$68,000/ha.

Figure 4. Summary of cover construction costs for case studies where reliable data is available.
