Slope Design for Maricunga Mine in Chile.

E. Hormazabal *SRK Consulting, Chile*

C. Almarza *Kinross Gold Corp., Chile*

E. Pizarro *SRK Consulting, Chile*

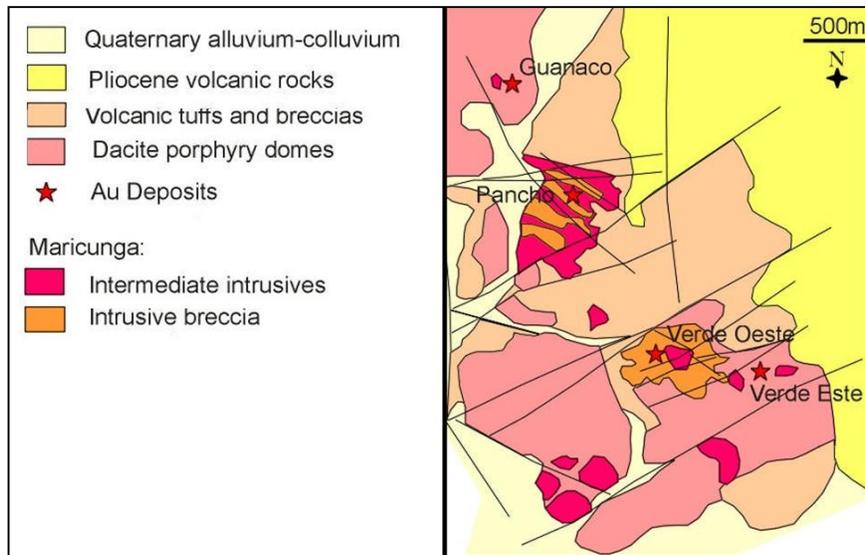
Figure 2. District geology of Verde and Pancho deposit.

The regional geology is dominated by Miocene to Pliocene volcanics and portions of an exposed Paleozoic-Triassic basement (see Figure 2). The Pancho and Verde deposits are part of the Maricunga Metallogenic District. The older basement of Paleozoic and Mesozoic igneous and sedimentary rocks is unconformably overlain by the Miocene volcanic rocks. The volcanics are related to a series of large calc-alkaline stratovolcanoes. The volcanics have been subdivided into two sub-belts using K-Ar dating into western early Miocene (24 Ma to 20 Ma) and eastern middle Miocene (14 Ma to 13 Ma) sub-belts. High angle reverse faults caused by regional compression have juxtaposed these two volcanic belts. The same compressional event resulted in low angle thrusting in areas west and north of the property.

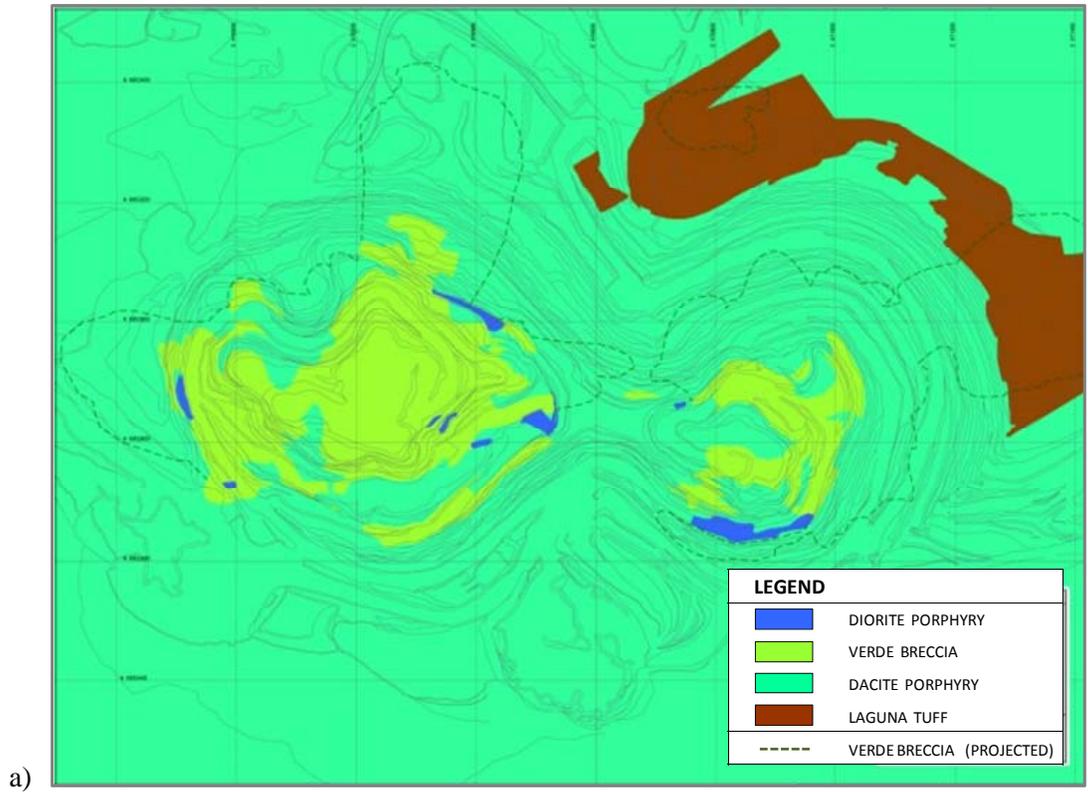
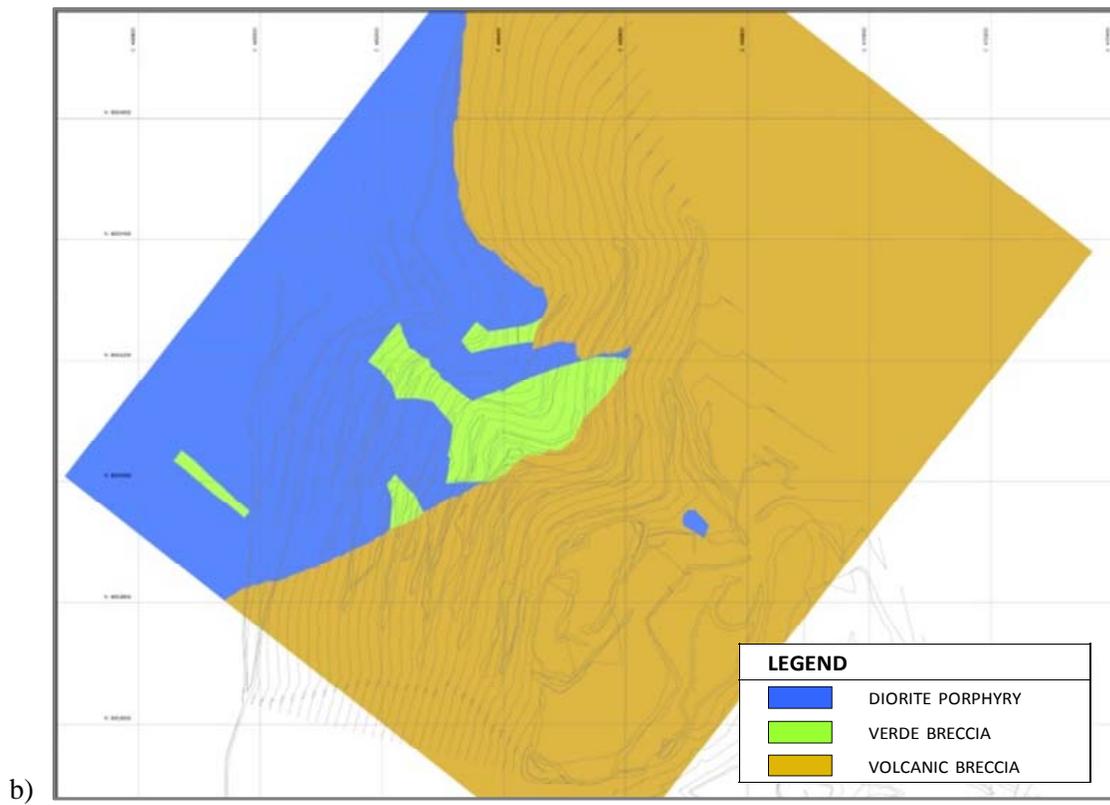
Figure 3. Lithologic units at a) Verde Pit, and b) Pancho Pit.

Gold mineralization at Maricunga has been interpreted to be porphyry style gold systems. At Verde West, gold mineralization is centered about an elliptical porphyry plug measuring 175 m by 100 m and oriented at N30°W. At Verde East, the porphyry plug measures 130 m by 80 m and is oriented at N35°E. The porphyries occur within a sequence of intermediate tuffs, porphyries, and breccias that are the host rocks to the gold mineralization. Lithological interpretation at Verde has identified four main lithologic units. These are: Dacite Porphyry, Diorite Porphyry, Verde Breccia (Intrusive) and Laguna Tuff.

The gold mineralization at Pancho is also described as porphyry style mineralization. It occurs within a sequence of intermediate tuffs, porphyries, and breccias that are the host rocks to the gold mineralization. Lithological interpretation has identified six major lithologic units. These are described below from older to younger rocks: Dacite Porphyry, Diorite Porphyry, Verde Breccia (Intrusive) and Volcanic Breccia.

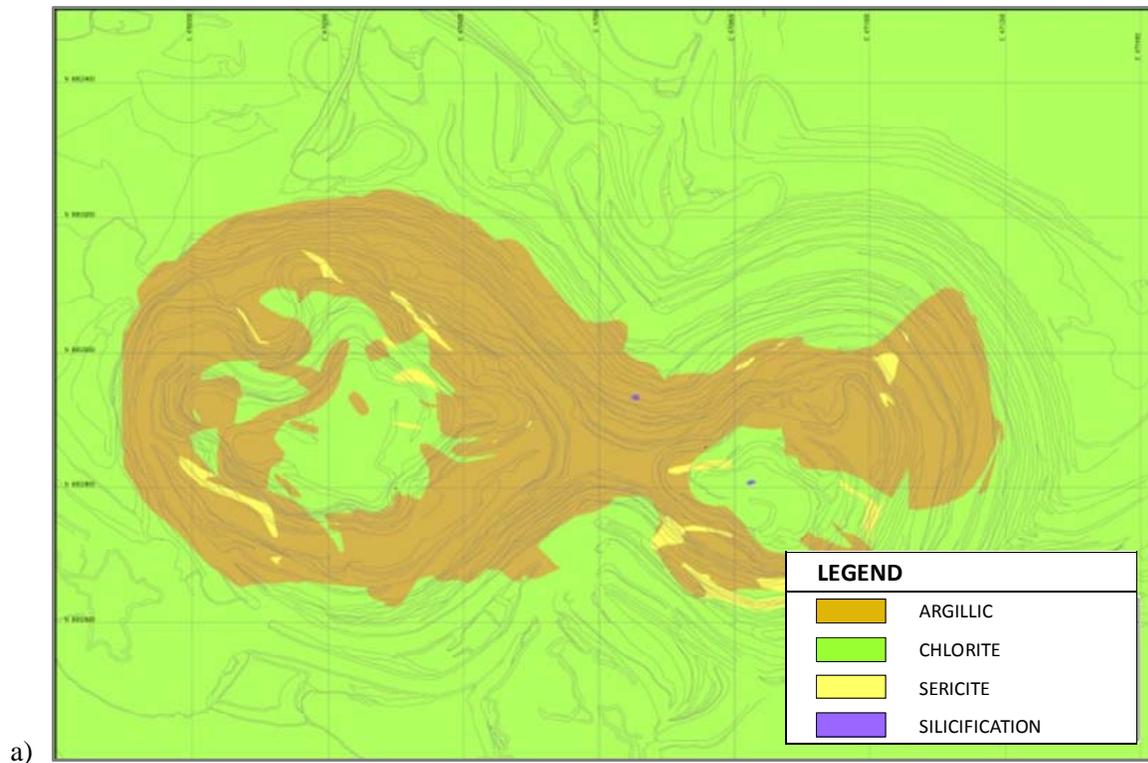
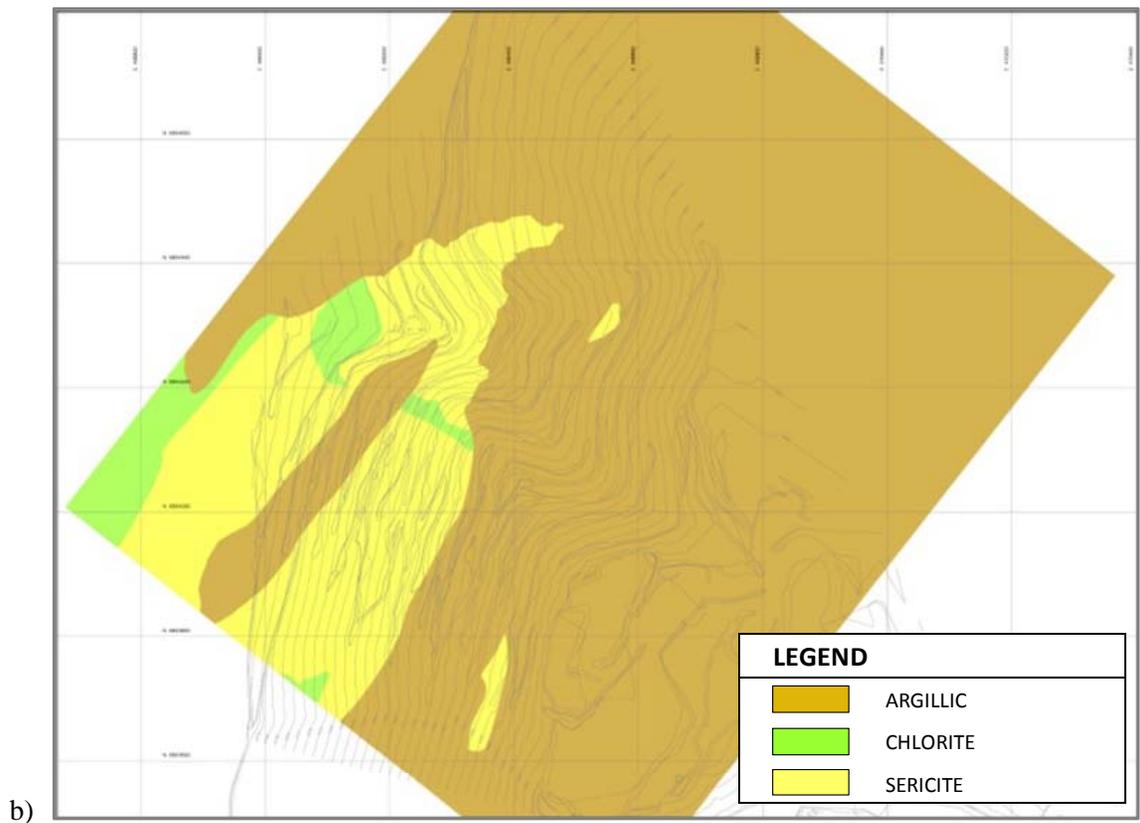
Figure 4. Alteration types at a) Verde Pit, and b) Pancho Pit.

Alteration assemblages observed at Verde and Pancho are generally supportive of porphyry style mineralization but the intensity of the alteration fabric tends to be weak. Potassic alteration has been observed at Verde but generally tends to be rare. Silicification is local and patchy. Propylitic alteration, although variable on the small scale, appears ubiquitous on the mine scale and in global terms does not change laterally or vertically.

Supergene alteration, which directly affects gold recovery, occurs deeper within fracture and fault zones. Sericite and chlorite are replaced by clay minerals, magnetite by hematite and pyrite by jarosite. The oxidation and leaching by meteoric waters has penetrated to variable depths within the deposits depending on the fracture intensity and faulting. The supergene alteration is accompanied by the deposition of limonite, manganese oxides, clay, sericite, and jarosite along with gypsum in the argillic altered zones.

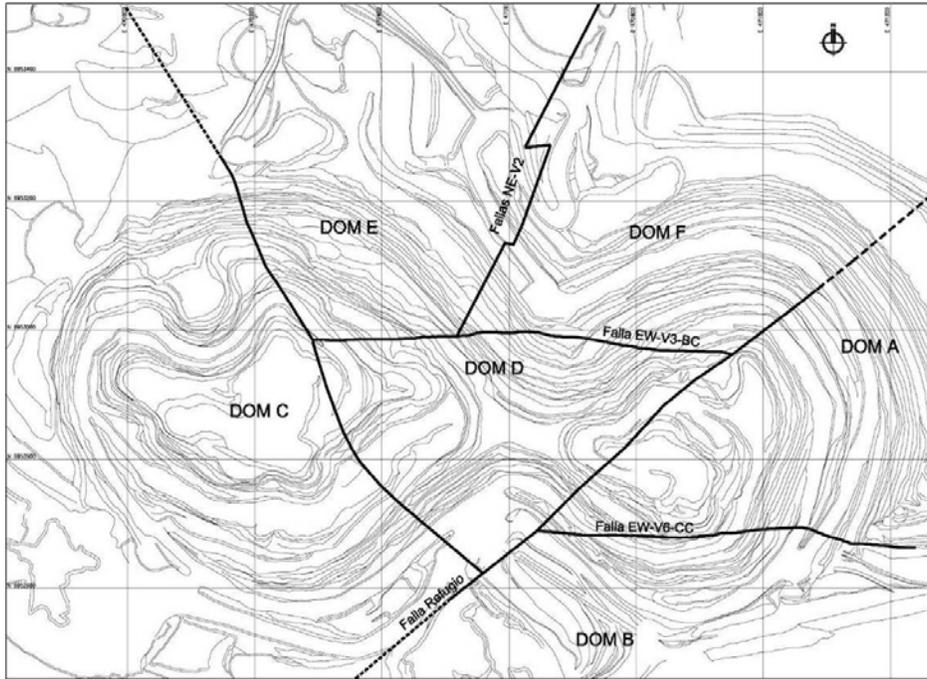
Figure 5. Structural domains in the current Verde Pit.

According to the geotechnical information provided by surface mapping and geotechnical logging of several campaigns in the past (Golder, 2003, SRK 2009 & 2010), 6 structural domains can be defined at Verde pit (domains A, B, C, D, E & F) and 3 structural domains at Pancho pit (domains A, B & C). Figures 5 and 6 show these structural domains in the current Verde and Pancho pits.

At Verde, the main structural trends observed are major E-W subvertical faults, and secondary structures in NE-SW and NW-SE orientations. The latter two orientations are those associated with the presence of gold-bearing veinlets. Previous models have shown the E-W fault zones as continuous faults, crossing both the Verde and Pancho pits, however inspection of the map data and pit exposures, indicates that the E-W fault zones are composed of a number of *en echelon* sections, which have right-stepping offset, with subsidiary zones of NW-SE and NE-SW faulting concentrated around the termination and offset of the E-W faults. This is consistent with observations in the pit of intense fracturing and veining where faults of WNW-ESE and NW-SE trend intersect. These secondary faults are those that contain the gold-bearing veins, and therefore, there is a close relationship between the fault offsets and concentrations in gold grade (Goodman, 2010).

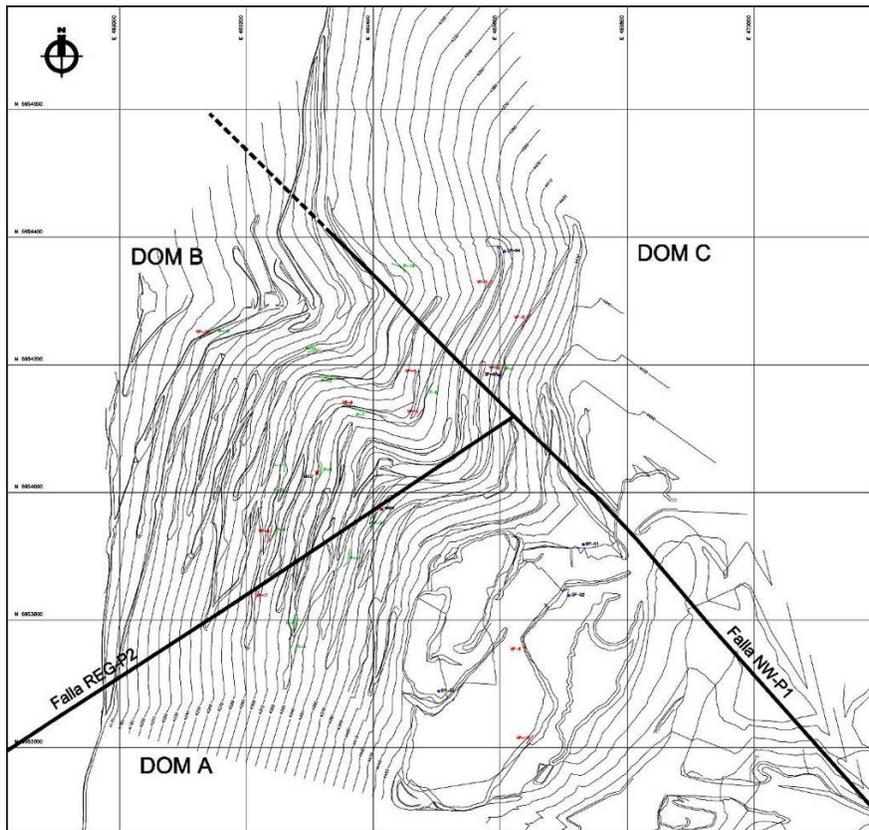
Figure 6 Structural domains in the current Pancho Pit.

At Pancho, the main structural trends observed are major E-W subvertical faults, and secondary structures in NW-SE orientations. The lack of NE-SW faults observed at Pancho may be a result of the available outcrop lying on a NE-SW trending slope, which is close to the strike of such structures.

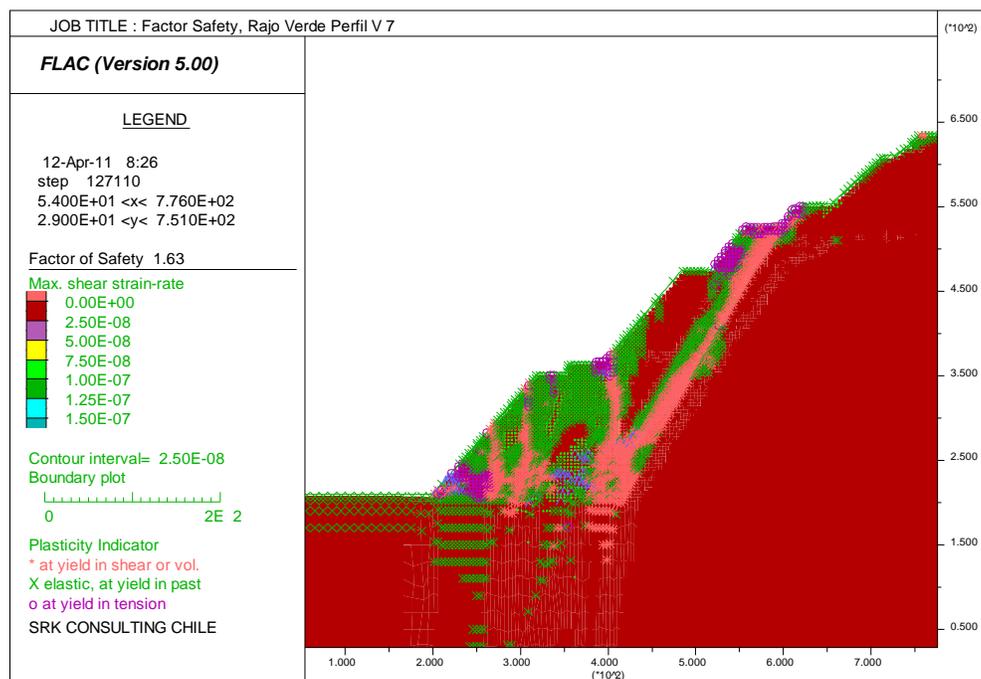
Figure 8. Plasticity indicators concentrated in fault zones in cross section V7 of Verde Pit Phase 4. Factor of Safety FOS = 1.63.

- Maximum horizontal displacements occur locally in the lower benches corresponding to the fault zone and Breccia Secondary Unit and do not exceed 1.25 m. Hence, if the ratio between the slope crest's horizontal displacements and the slope height is smaller than 1.0% ($1.25/340 \approx 0.4\%$). Hoek & Karzulovic (2000) suggested that slopes begin to show signs of instability when the ratio is greater than 2%.
- Large deformations are observed at the toe of the slope due to fault zones (poor rock mass quality).
- The plasticity indicators (failure through the rock mass by shear and/or tension, slippage along ubiquitous joints) indicated that tensile failures occur in the lower slope.
- The factor of safety computed with the strength reduction technique is 1.63 and the failure surface reach 340 m of height (see Figure 8). The FS obtained from limit equilibrium method was 1.78.

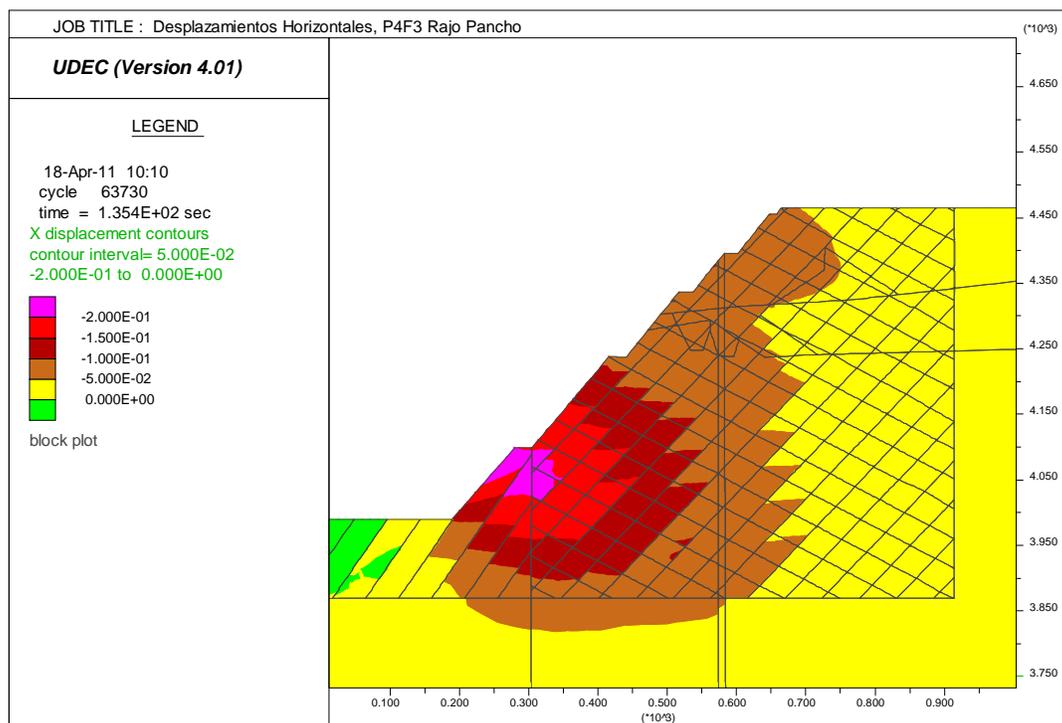
Figure 9. Horizontal displacements at section P4 of Phase 3 of Pancho pit.

- Maximum horizontal displacements occur locally in the lower benches corresponding to fault zone and Breccia Secondary Unit and do not exceed 0.2 m. Hence, if the ratio between the slope crest's horizontal displacements and the slope height is smaller than 1.0% ($0.2/480 \approx 0.1\%$). Hoek & Karzulovic (2000) suggested that slopes begin to show signs of instability when the ratio is greater than 2%.
- Large deformations are observed at the toe of the slope due to the water table effect.
- The plasticity indicators (failure through the rock mass by shear and/or tension, slippage along ubiquitous joints) indicated that tensile failures occur in the lower slope.
- The factor of safety computed with the strength reduction technique is 1.37 and the failure surface reach 480 m of height (see Figure 9). The FS obtained from limit equilibrium method was 1.55.

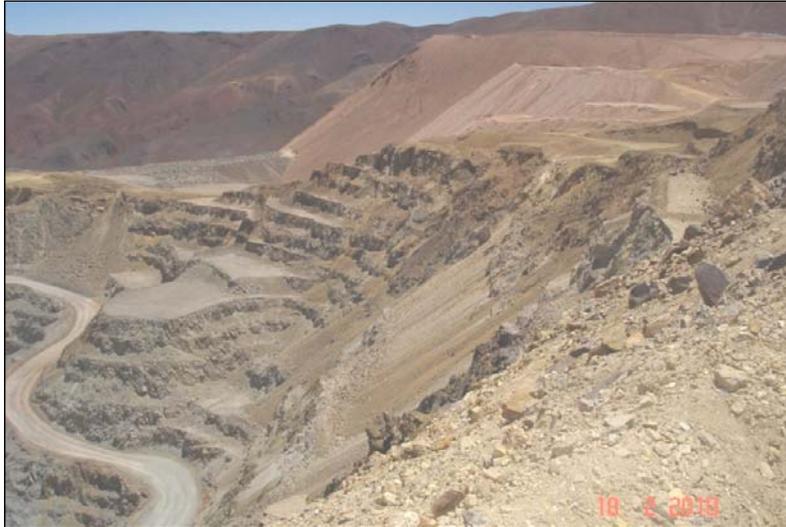
Figure 9. View of the North face taken from Verde West pit.

It is clear from Figure 9 that the benches of Verde pit in general were in a very poor state with virtually no catch berms available and rubble filling whatever berms that did exist. Multiple bench failures have occurred at several locations around the pit perimeter ranging from rock mass failure to structural induced failure mechanisms. The slope failures experienced resulted partly from design but mostly from poor blasting control.

It is clear that blast damage of the slope faces is excessive in terms of modern practice and standards of house-keeping. Poor blasting practices are a major cause for berm loss and screed development. It should be noted that the high degree of fracturing in the rock mass requires special care in blasting practices to avoid damage and berm loss. While it is not expected that pre-split blasting of these bench faces would result in perfectly smooth bench faces, it would avoid the excessive damage to the bench faces and retain intact berms for rock fall retention. The fundamental reasons for the blast damage in Verde pit were:

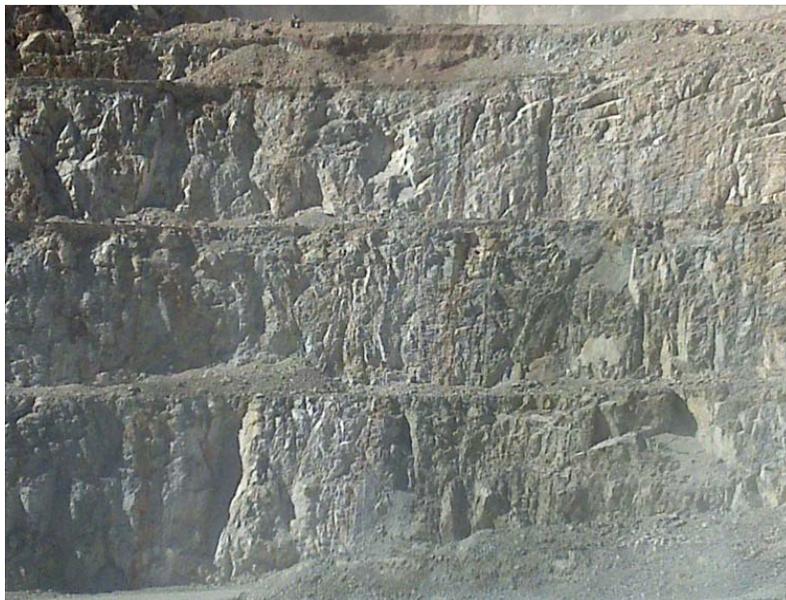
Figure 10. Double benches achieved using controlled blasting (6×6×10 m, Ø 9 7/8“and pre-shearing Ø 5 1/2“) in Pancho pit.

During 2010 and 2011, an extensive blasting program had been carried out including trial blasting for different units, vibration measurements, alternative types of explosives, and drillholes diameters (Rock Blast Design Ltda., 2011). The results can be seen in Figures 10 and 11, which indicates the current blasting practices for double benches (20 m) of a 70° bench angle using controlled blasting can be observed.

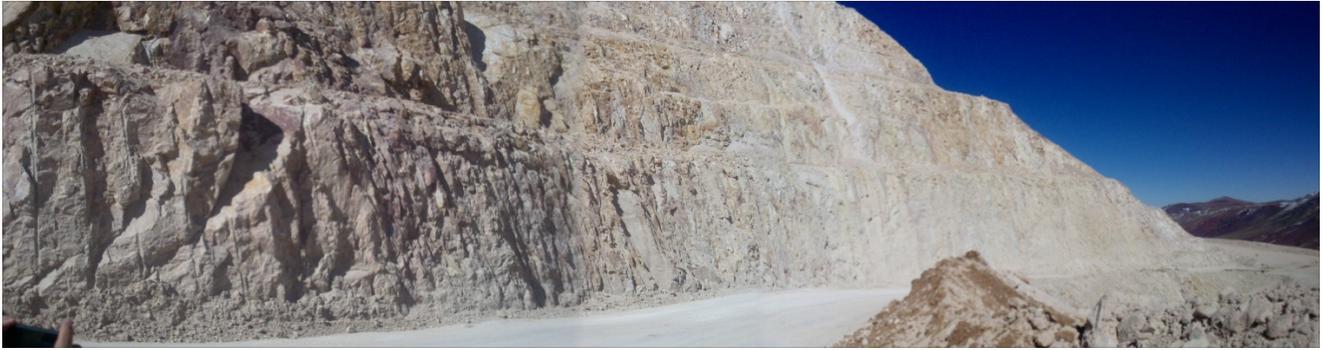
Figure 11. View of the current North wall of Pancho pit. Detail of the well groomed double benches achieved using controlled blasting ($6 \times 6 \times 10$ m, $\varnothing 9 \frac{7}{8}$ " and pre-shearing $\varnothing 5 \frac{1}{2}$ ").

The recommended slope design requires good operational and blasting practices, and also efficient slope instrumentation and monitoring system. Currently, the quality of blasting allows achieving well groomed 20 m double benches, with 70° bench face inclinations, and the pits walls are under continuous monitoring by a robotic Leica APS-Win system and one Reutech radar system (model MSR-300). The use of radar monitoring equipment provides excellent coverage for the safety of personnel and equipment and is essential in the current situation and should be continued into the future final phases. It is important that a suitable evacuation procedure be developed and integrated into the monitoring system for risk management.
