# The Integrity of Cover Systems — An Update

G W Wilson<sup>1</sup>, D J Williams<sup>2</sup> and E M Rykaart<sup>3</sup>

## ABSTRACT

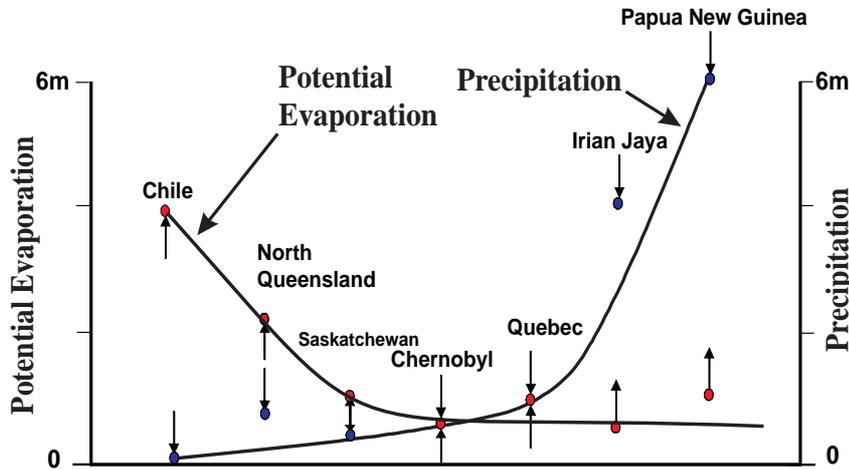
FIG 1 - Global variation in annual precipitation and potential evaporation.

Climatic conditions are paramount for cover design. Figure 1 shows annual precipitation and potential evaporation for several locations, and demonstrates the range of variations. Moisture availability will control the approach to cover design. It is widely known that current practice is to design covers to be barrier systems in wet climates and store/release systems in semiarid regions. Store/release cover systems have been adopted as best practice for some parts of Australia. Barrier-type cover systems have been used extensively for landfill systems in the United States. Store/release covers and barrier covers rely on the physical properties of the soil within the different zones of their profile. Figure 2 illustrates the near surface profile of the soil cover environment. The profile consists of an active upper layer that supports the surface biosphere. This layer hosts biomass, organic nutrients and microbial communities. Large fluctuations in both temperature and water content prevail. The active layer is of greatest importance with respect to the performance of store/release covers as plant transpiration is critical to proper cover performance. In the case of barrier-type covers, which must maintain specific engineering properties with respect to permeability and high water retention, the barrier layer must be situated below the active zone.

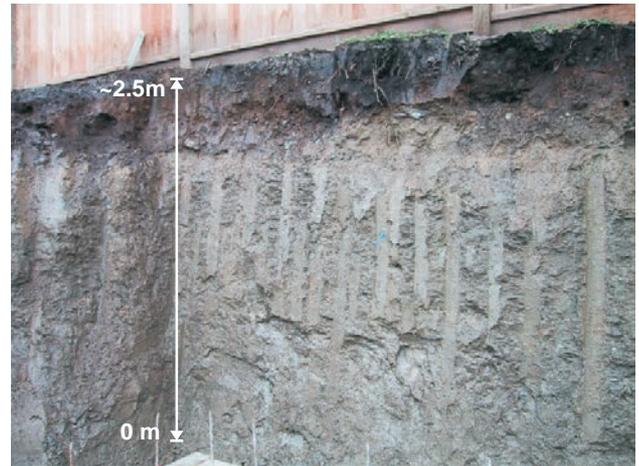
FIG 3 - Near surface soil profile at White Rock, British Columbia, Canada.

The thickness of the active zone is dictated by climate, soil type and vegetation. The active zone may be less than 0.5 m thick, as in the temperate rain forests of British Columbia, Canada near White Rock, shown in Figure 3. Alternatively, the active zone may be greater than 3 m thick, as observed in the semi-arid region of southern Saskatchewan, Canada, shown in Figure 4. It is interesting to note that both soils shown in Figures 3 and 4 are a silty clay matrix glacial till located along the 49th parallel. Furthermore, the value of potential evaporation at both locations is approximately 1000 mm per annum. The difference in the thickness of the active zone occurs as a result of the difference in rainfall (1000 mm in White Rock versus 400 mm at the southern Saskatchewan location) together with differences in the mean annual temperatures of 15°C (ranging between 0°C and 30°C) versus 5°C (ranging between -40°C and + 40°C) respectively. It can be seen that the soil profile shown in Figure 4 exhibits extensive fracturing associated with desiccations and freeze/thaw cycling. Clearly, any attempt to construct a barrier layer within the upper 3 m of this profile would result in a failure. In general, the primary mechanism for failure of barrier-type cover systems is that the active zone penetrates the barrier layer. Repeated cycles of wetting and drying as well as freezing and thawing produce environmental fatigue in the barrier layer. Highly plastic clays have the highest sensitivity to these stresses and develop a nuggety, fractured structure in the active layer, as shown in Figure 5, resulting in values of *in situ* hydraulic conductivity three and sometimes four orders of magnitude greater than the value measured in a compacted state in the laboratory.

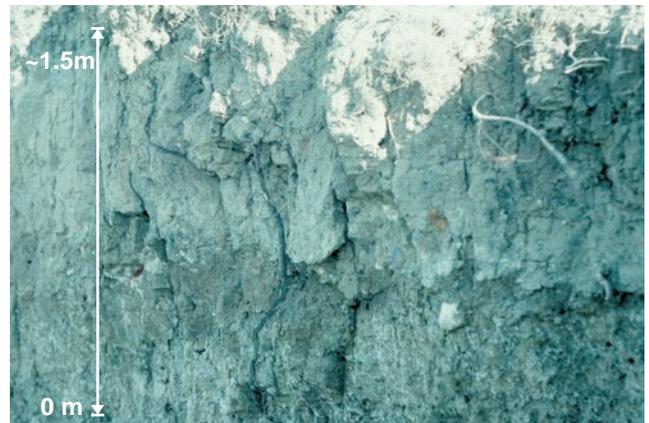
FIG 4 - Near surface soil profile in southern Saskatchewan, Canada.

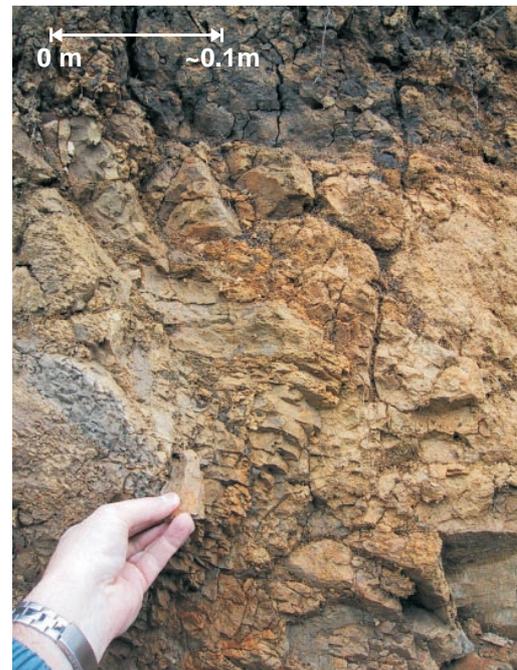
FIG 5 - Highly plastic clay with nuggety fractured structure.

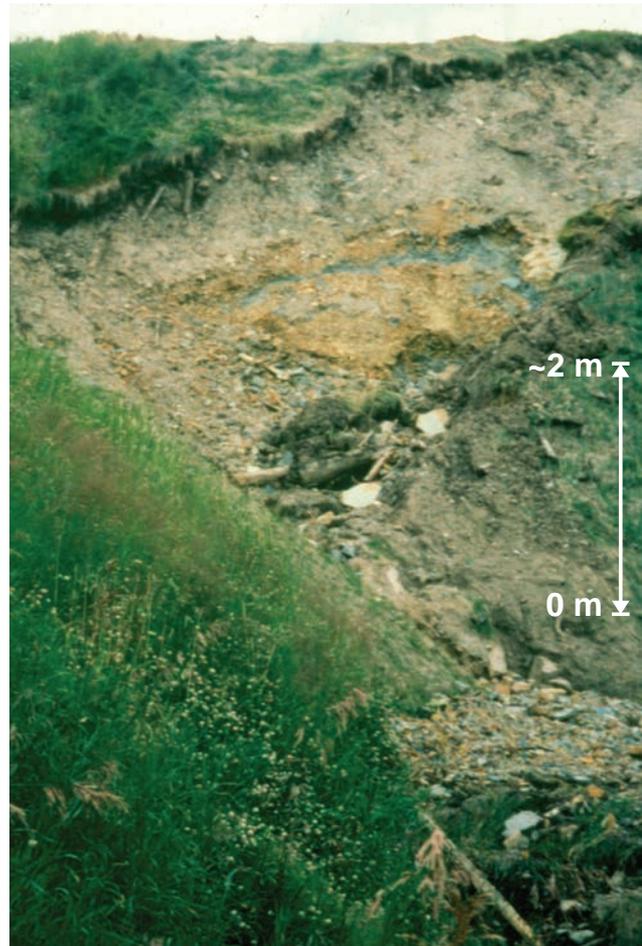
FIG 6 - View of erosional slump failure in an over-steepened slope.

Erosion is a failure mechanism that may destroy the integrity of any cover. Figures 6 and 7 illustrate erosional damage of the barrier cover at the Equity Silver mine and the store/release cover at Kidston gold mine respectively. A storm event at the Equity Silver with a return of approximately 200 years caused a slump to occur in an over-steepened region of the cover (Figure 6). Fortunately, this minor failure occurred in an isolated over-steepened section of the cover, and was readily repaired. The erosional gully shown at the Kidston site occurred in a non-vegetated section of a test cover during a typical summer storm. While minor failures were easily remedied at the Equity and Kidston sites, they illustrate the type of damage that may occur at full scale cover systems that are not properly designed. In general, the threat of severe erosion is considered of greatest risk to store/release cover systems on side slopes or where run-off may converge. This may be attributed to three key factors. Firstly, store/release covers are placed as loose, low-density materials. Secondly, the vegetative canopy is often stressed due to lack of rainfall and thus the surface of the cover becomes exposed and susceptible to erosion. Finally, the nature of semi-arid climate systems generally produces high intensity storms.

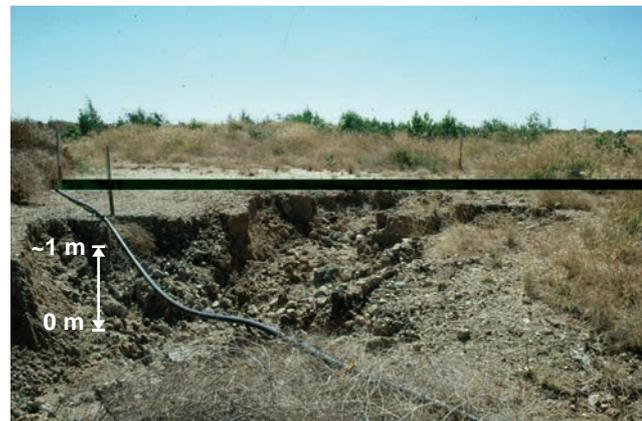
FIG 7 - Erosional gully in fine-grained soil due to high intensity storm.

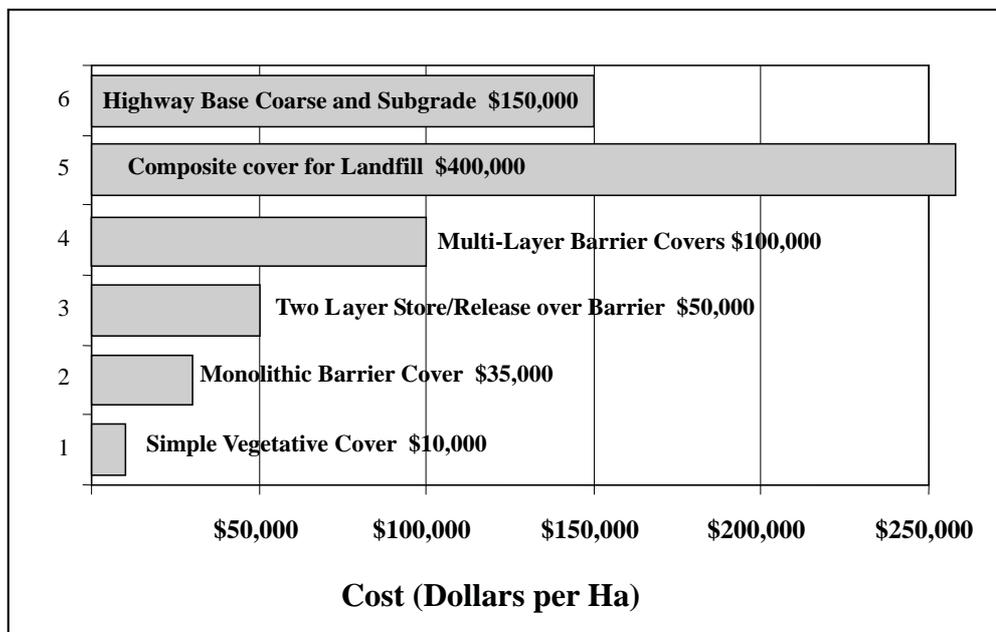
FIG 8 - Indicative costs for cover construction. Dollar amounts are approximate for construction in Australia, Canada and the United States, in local currency.

A key issue that must always be considered in the evaluation of performance, risk, benefit and integrity, is of course, cost. The range of capital investment required for the construction of soil cover systems is considerable. Figure 8 presents a simple plot for the approximate cost per hectare for typical cover systems. Experience with construction costs for cover systems has generally indicated that construction costs for covers built within the United States when counted in United States dollars are similar to construction costs for covers built within Australia when counted in Australian dollars. The same is true for Canadian construction. Dollar figures in this paper therefore represent costs for construction within Australia, Canada or the United States in the local currency. It can be seen the cost for the simplest cover intended to provide a base for re-vegetation only, is about \$10 000 per hectare. The barrier-type cover system constructed at the Equity Silver mine was approximately \$35 000 per hectare. The store/release cover at the Kidston Gold mine was in the order of \$50 000 per hectare. These covers can be considered to be among the least expensive to construct relative to most other cover systems. In the case of both Equity Silver and the Kidston Gold mine, an abundant source of suitable construction material was locally available. Furthermore, both cover systems were monolithic with respect to material type. The cost per hectare increases sharply with the number of layers and skill required to construct more sophisticated covers. In general, for most multilayer covers, whether constructed with compacted layers, storage layers, or capillary barriers, the cost usually rises to \$100 000 per hectare (Aubertin, 2002). The cost for composite covers, with the inclusion of a geosynthetic clay liner (GCL) and internal drainage layers may rise even further to \$400 000 per hectare (Benson, 2002b). Clearly, the value of any cover system must be addressed in terms of cost.

In general, compacted clay barrier-type covers are known to provide the poorest performance. At the same time, there is no reason to select this type of cover on the basis of cost. Compacted clay covers provide the poorest performance of all cover systems and thus are given a rank of low integrity versus high cost. Alternatively, the store/release covers, such as that constructed at the Kidston Gold mine, have shown excellent performance over an extended period of time. Additional observation and experience for store/release cover systems in the arid and semi-arid regions of the United States have also shown excellent performance with respect to the reduction of water infiltration to values approaching zero. Store/release cover systems depend on the natural cycles within the active zone, hence long-term integrity for properly designed covers maybe expected. Construction costs for store/release cover systems are reasonably low. Given the high performance and low cost, store release covers appear to provide good value.
